# Manhole Inspection Summary

Manhole # S15G1\_005MH

Insp Date: **4/17/08 10:58 AM**

**Location** Address: **3051 gable-patapsco industrial complex**

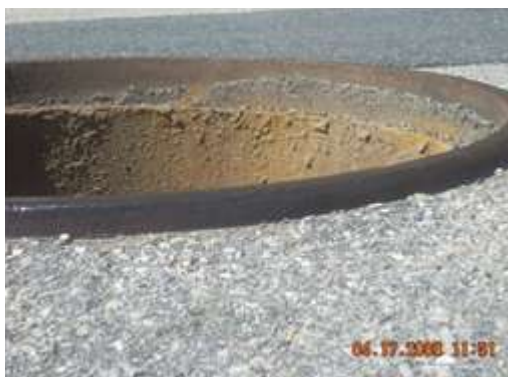
misc

above grade

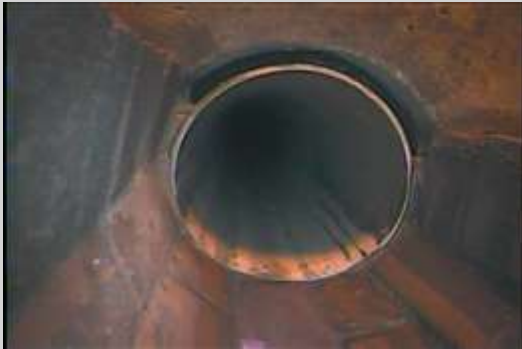
12 O'Clock Outflow

8 in. Circular Gravity Sewer  
Pipe Out @ 12 O'Clock

Pipe Height: **8.4** (in.) Rod and Bar (Angled)  
Pipe Material: **PVC** ☐ Pipe Lined  
Invert Depth: **9.54** (ft.) Flow Characteristics: **Slow**  
Deposits: ☒ None ☐ Mud ☐ Sludge ☐ Debris ☐ Grease  
Silt Depth: **0** (in.) Deposits Extent:  
Infiltration: **None** Pipe Seal Cond: **Sound**

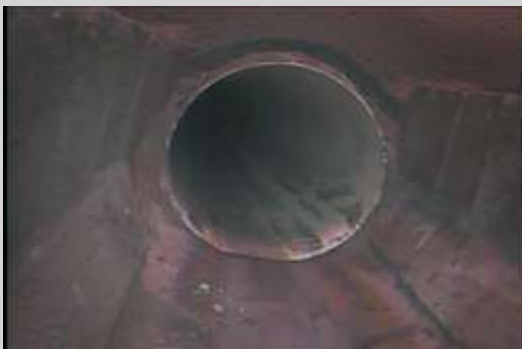
6 O'Clock Inflow

8 in. Circular Gravity Sewer  
Pipe In @ 6 O'Clock

Pipe Height: **8.4** (in.) Rod and Bar (Angled)  
Pipe Material: **PVC** ☐ Pipe Lined  
Invert Depth: **9.43** (ft.) Flow Characteristics: **Slow**  
Deposits: ☒ None ☐ Mud ☐ Sludge ☐ Debris ☐ Grease  
Silt Depth: **0** (in.) Deposits Extent:  
Infiltration: **None** Pipe Seal Cond: **Sound**
